**Crudine Ridge Wind Farm (SSD-6697) MOD1| Audit Response**

# Crudine Ridge 132/33kV Substation Soil and Water Management - Action Plan

## GEZ Consortium – Crudine Ridge Wind Farm Project

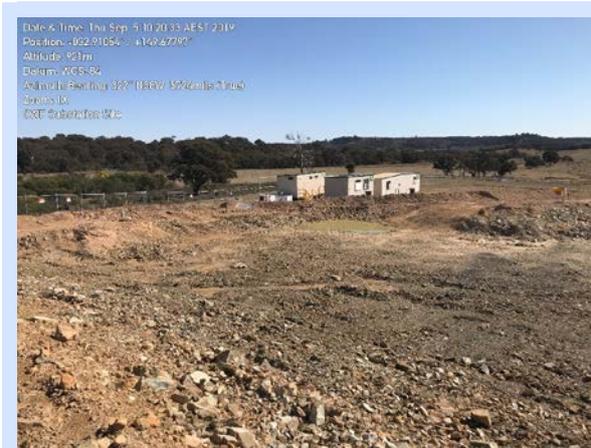
Nearly all of the dirty water on site is either trapped in low points within the excavation or passes through some form of a sediment trap. The main sediment trap at the lowest point on site has collected a reasonable amount of sediment and no sediment was observed past the outlet of this structure. However the fabric underneath the rock outlet has started to decay and fine clay material can now wash out from beneath the rock, and the structure could potentially fail if subject to a flow event.

Photo 1. Water trapped in a low point of the excavation near the site offices.

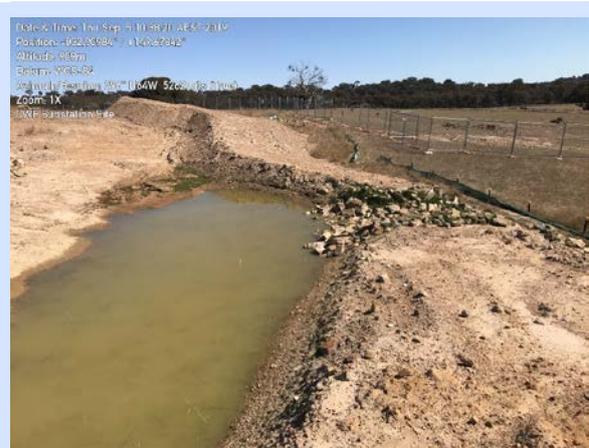
Photo 2. Water Trapped in the sediment trap at the lowest point on site.

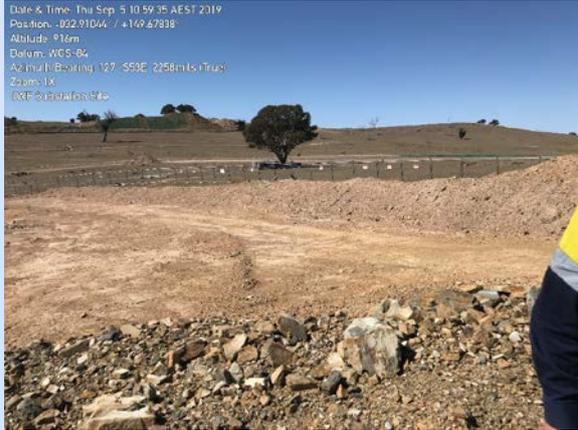
Most of the clean run-on water is diverted around the site by what could be considered a topsoil bund and seems to be working well enough to date. The flow paths for drainage around the site are mostly exposed, but there is rock lining in some of the steeper sections. The flat grade on the channel at the bottom of the site is helping to trap sediment in flow path. However the exposed channels on steeper sections have the potential to erode during a storm event causing runoff.

Photo 3. A topsoil bund diverting clean water around the site.

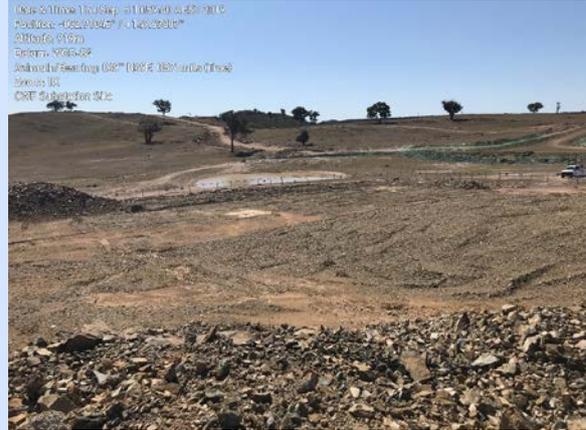
There is a significant amount of exposed rock and gravel on site which is a good thing in that it provides a stable ground cover and helps reduce the generation of sediment during a rainfall event causing runoff.

Photo 4. An example of the rocky material on the surface of the excavation.

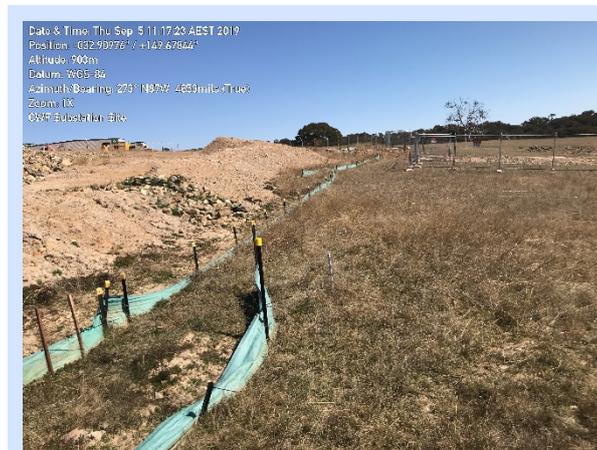
#### **Item 1** *Sediment Fence below Topsoil Bund Bottom of site*

The sediment fence at the bottom of the site below the topsoil bund has perished and is now ineffective. The fabric outlets on the sediment traps is also starting to break down and exposing the soil beneath to a concentrated flow increasing the potential for failure.

Photo 5. An example where the sediment fence has deteriorated and needs to be replaced.

It is recommended to replace the sediment fence at the bottom of site with a better quality fabric to give it greater longevity such as Silt Fence 2000 utilising the steel posts that are already there.

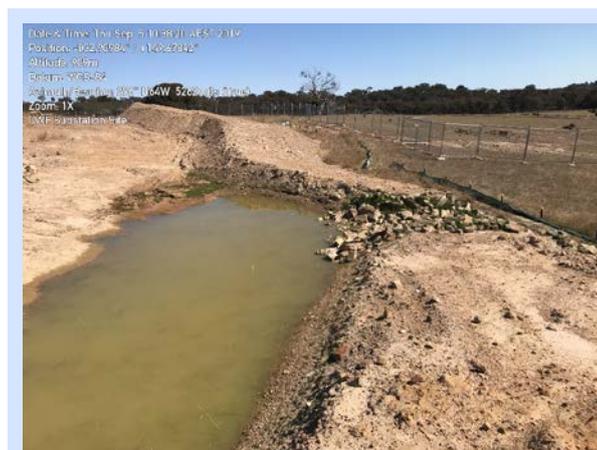
#### **Item 2** *Sediment Trap Bottom of Site*

Photo 6. An overview of the sediment trap with rock lined spillway.

For the sediment trap at the bottom of the site it is recommended to,

- Replace the rock lined spillway so that it has A44 geofabric placed underneath the rock work to prevent the erosion of fine soil material beneath, and widen the outlet to a minimum of 2m in the base of the channel to reduce the risk of potential failure of the structure, and
- Place a rock/bidum sediment trap on the outlet of the rock spillway a minimum of 4m wide to better dissipate outflow from the spillway in a storm event.

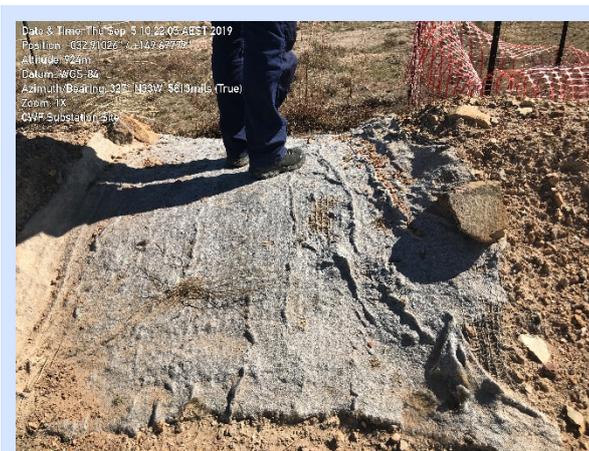
Photo 7. The fabric on the spillway is starting to break down and will erode in a storm event.

For the low point in the north-east corner of the site it is recommended to,

- Replace the existing spillway with a rock lined channel a minimum of 2m wide, underlain with geofabric, and
- Remove accumulated sediment from low point to maintain 5m<sup>3</sup> capacity.

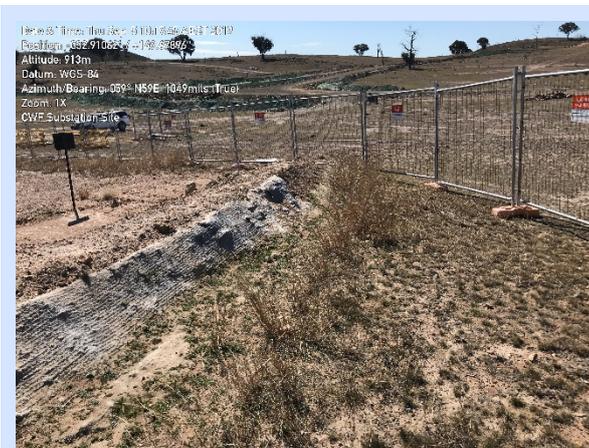
**Item 4 Clean Water Diversion South East Corner**

Photo 8. The outlet of the clean water diversion on the south east corner of the site.

It is recommended to place a rock/bidum check on the outlet of the clean water diversion a minimum of 3m wide to trap any sediment generated from the topsoil bunds, and better dissipate energy from the outlet in a storm event.

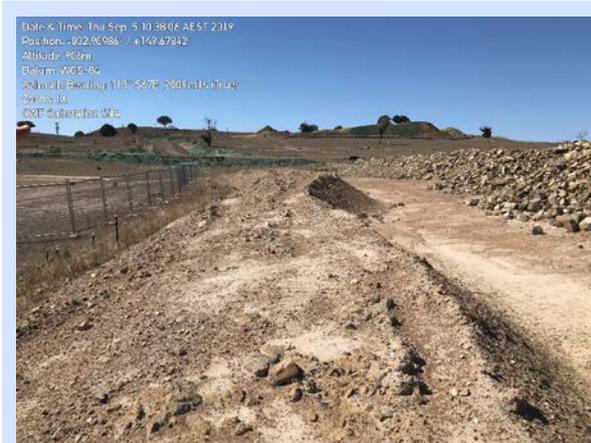
The topsoil bunds at the top and bottom of the site have been roughly formed and are generating minor levels of sediment where there is loose material and concentrations of runoff coming off the top of the bund and eroding the sides. Note that the topsoil on site is extremely shallow and infertile and any good topsoil is very limited. The bunds appear to contain a significant amount of dispersible subsoil which has not grown any vegetation despite efforts over time to do so. The dispersible soils are a major limitation on site and will continue to contribute to the mobilisation of sediment.

Photo 9. The topsoil bund at the bottom of the site with a flat top that results in concentration of runoff from the surface in rills down the side.

Firstly it is recommended to reshape the topsoil bunds at the top, bottom and around both sides of the site to make the banks smooth and rounded, so that they shed drainage in sheet flow rather than concentrating small flows on uneven surfaces resulting in rill erosion.

On completing shaping of the topsoil bunds it is recommended to stabilise the surface to minimise the potential for the generation of sediment. Considering the high risk of failure with revegetation measures due to the extremely poor soil type it is recommended that a two stage approach is taken to stabilise the topsoil bunds. Firstly an effort should be made to establish a cover crop on the topsoil bunds to maintain some form of biological activity in the topsoil stockpiles albeit at a limited level. Otherwise of what good topsoil remains will only degrade over time. Secondly it is recommended to spray the surface of the topsoil bunds with a soil stabiliser to reduce the generation of sediment. The following measures are recommended,

- Apply Japanese Millet at 20 kg/ha, Rye Grass Seed at 10 kg/ha and Sub Clover at 5 kg/ha
- Apply fertiliser, Croplift 15 at 250 kg/ha, and
- Spray the topsoil bunds with anionic bitumen at 1-2 l/m<sup>2</sup>

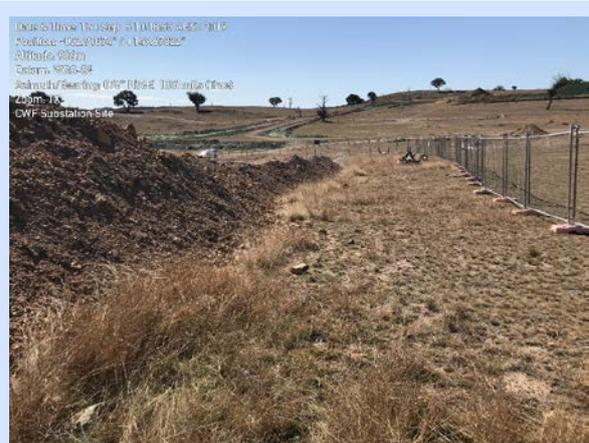
Photo 10. The topsoil bund at the top of the site directing clean water away.

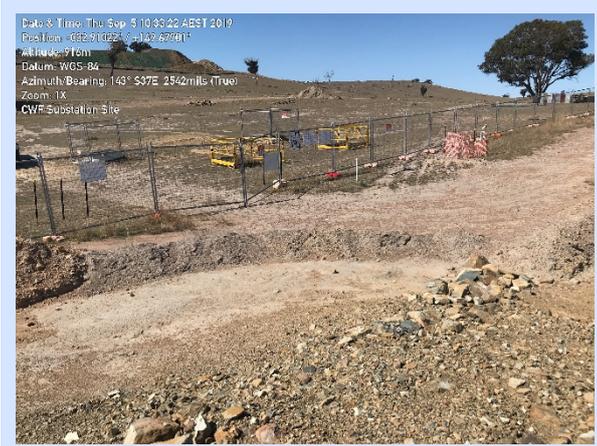
### Item 6 *Drainage at the Gate*

Photo 11. Site for trafficable cross bank near gate

There is small area of dirty water below the topsoil bund on the south-east corner of the site missing the controls below. It is recommended to place a trafficable cross bank at the gate to direct this drainage into the dirty water system.

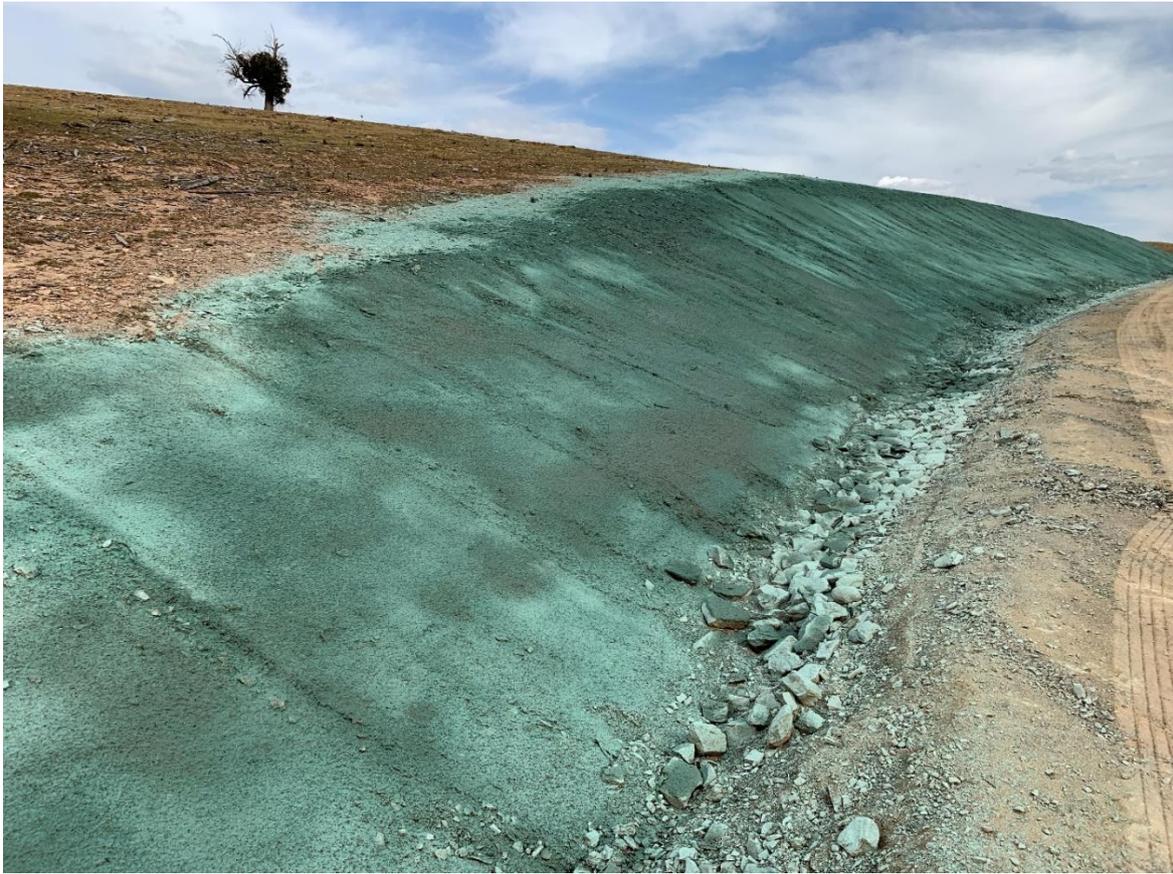
**Figure 1:** Heavy compost blanket applied to batter in CG4 (October 2019)

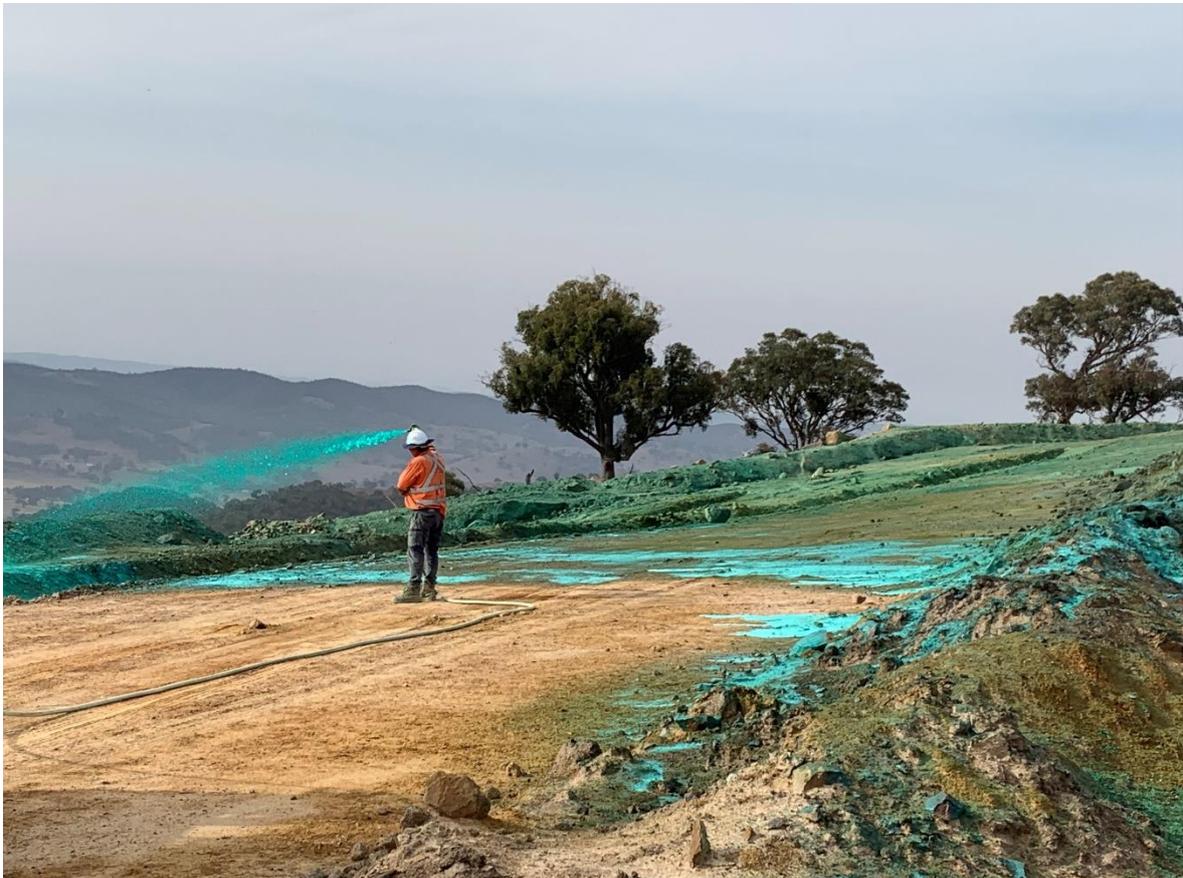
**Figure 2:** Temporary polymer stabilisation applied to works on hold (Track 6, CG1 October 2019)

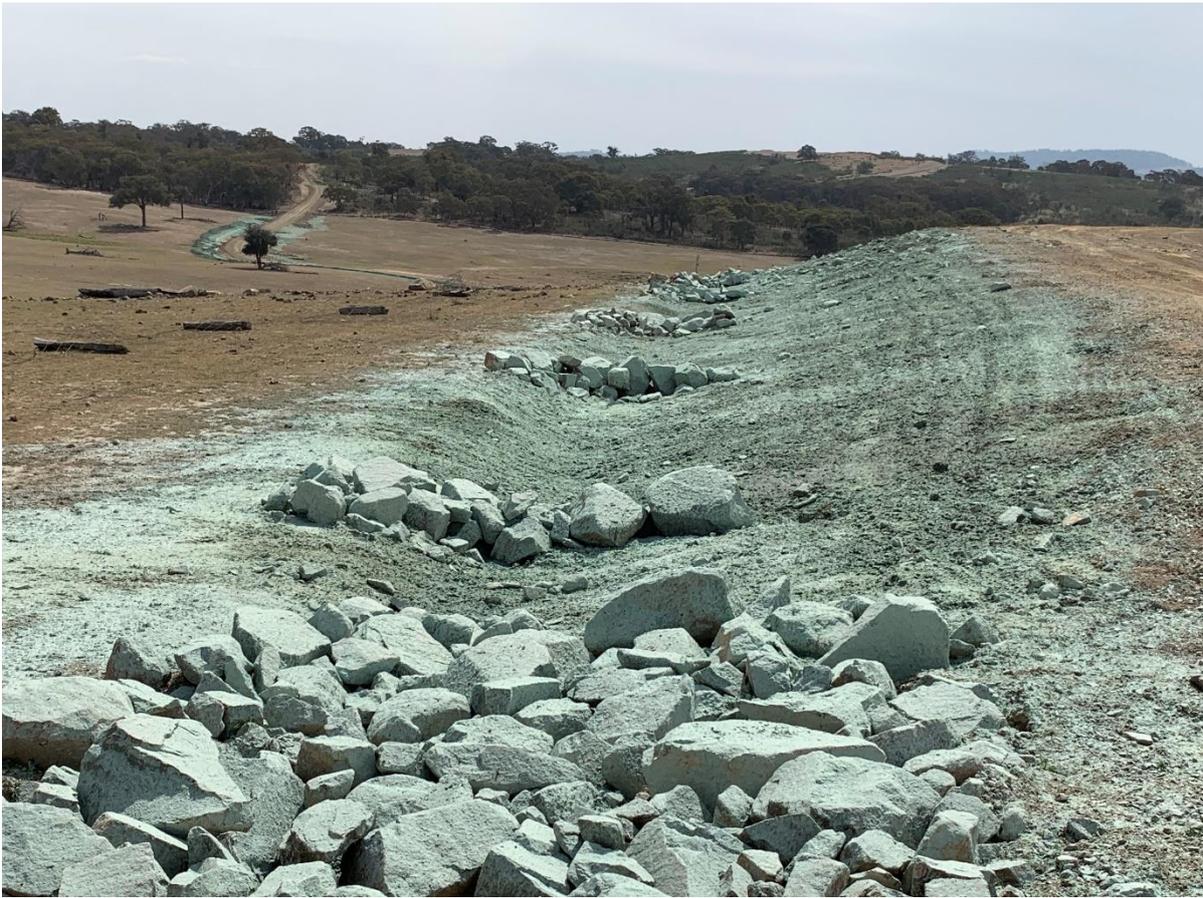
**Figure 3:** Heavy compost blanket applied to batch plant bench drains (October 2019)

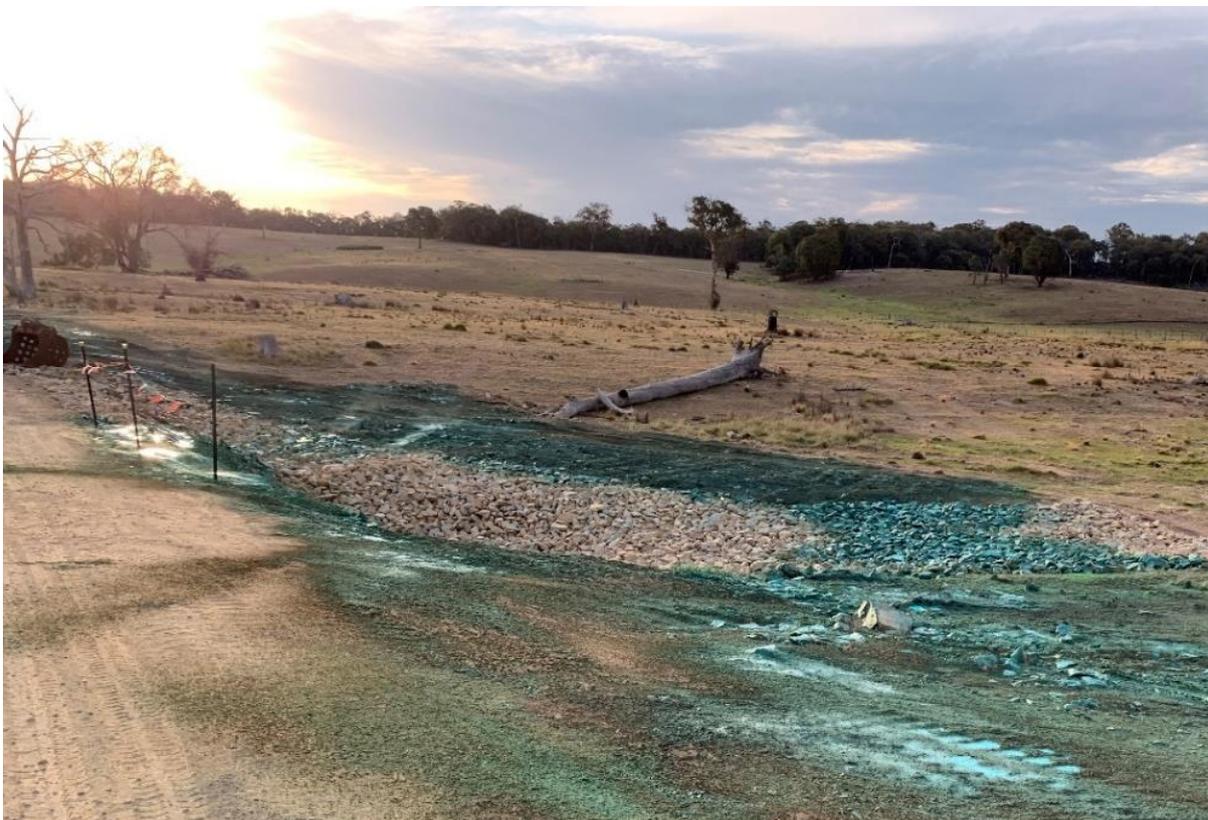
**Figure 4:** Cross drain outlet reset and temporary polymer stabilisation applied in CG4 (October 2019)

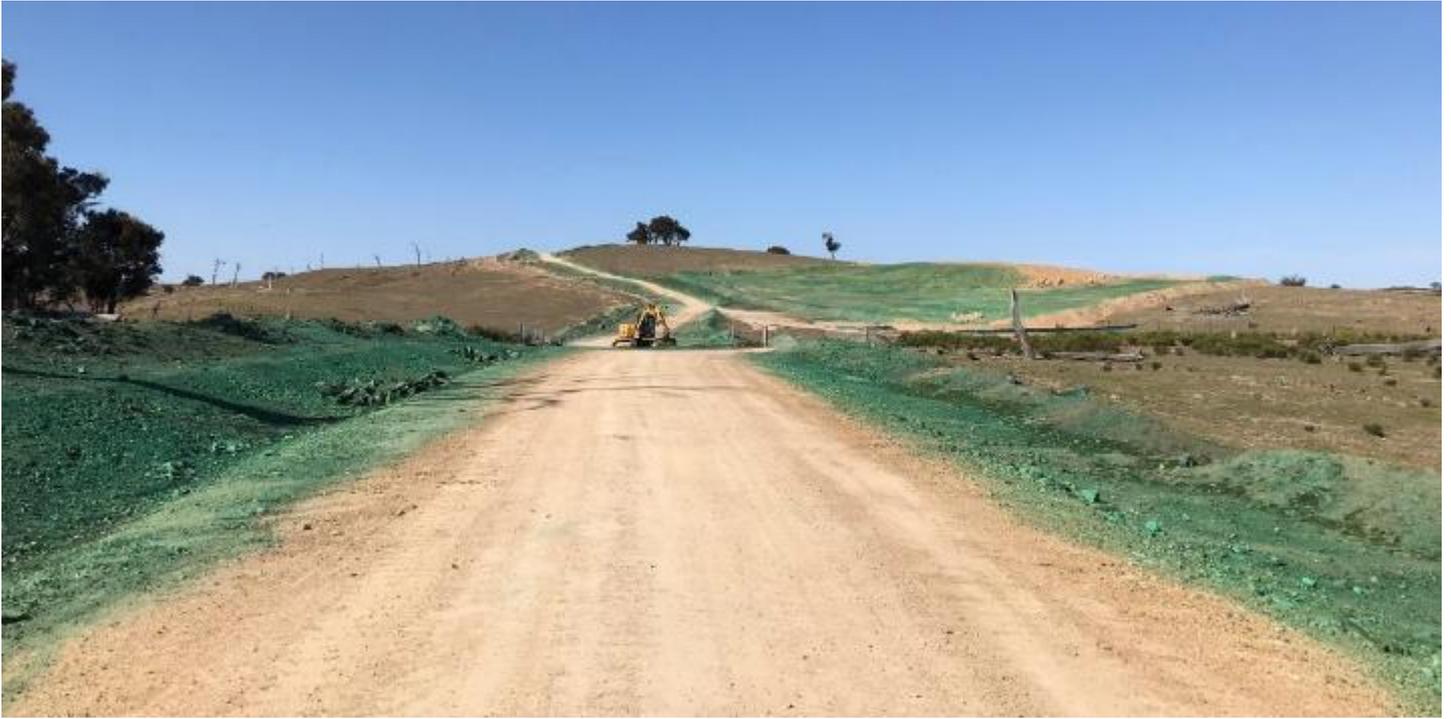
**Figure 5:** Temporary polymer stabilisation (second coating) applied to Track 1, CG1 higher risk areas where works are currently on hold (September 2019)

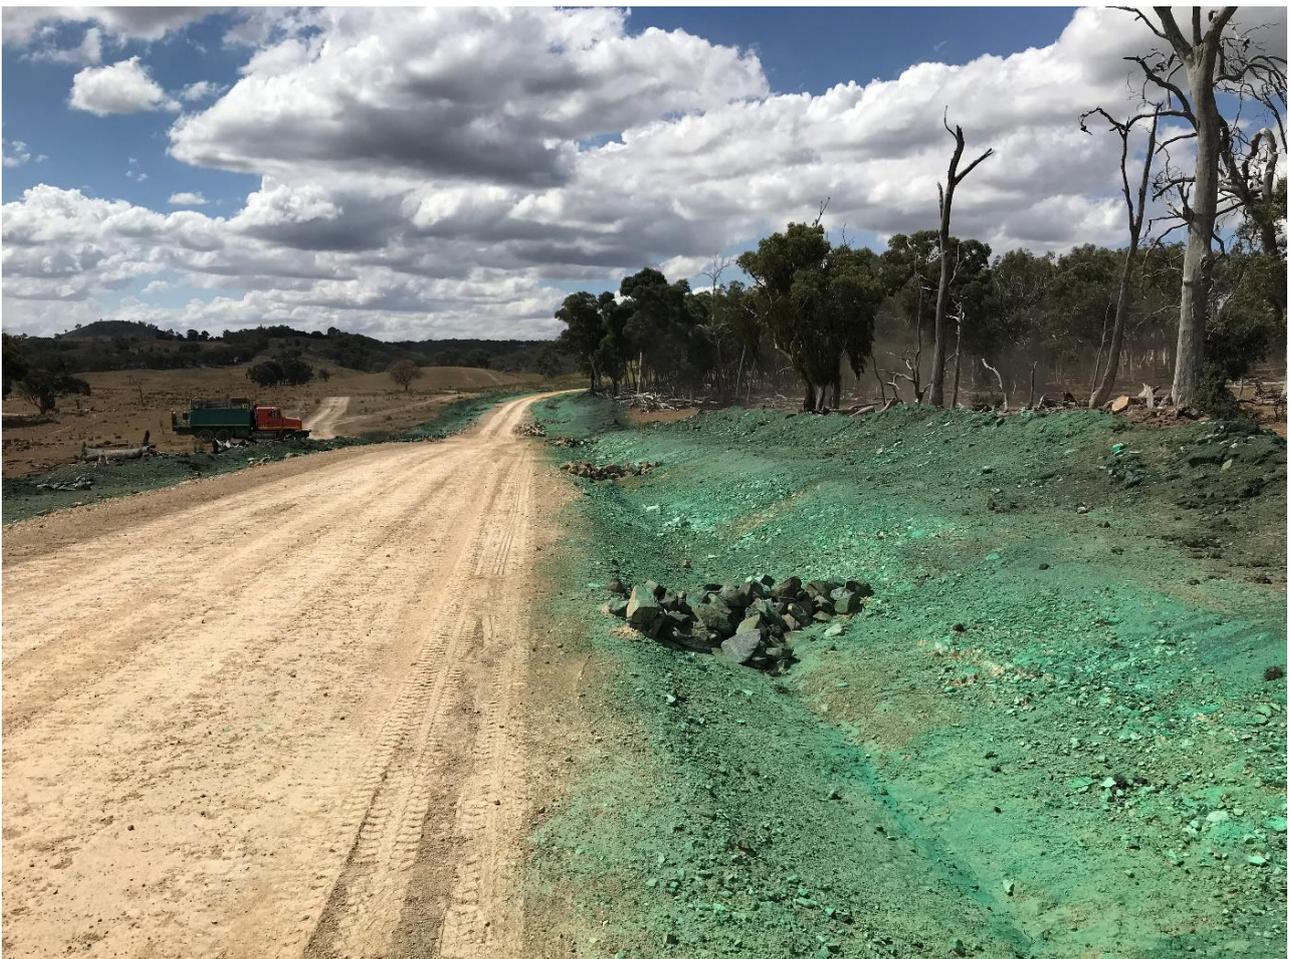
**Figure 6:** Temporary polymer stabilisation (initial coating) applied to Track 1, CG1 higher risk areas where works are currently on hold (March 2019)

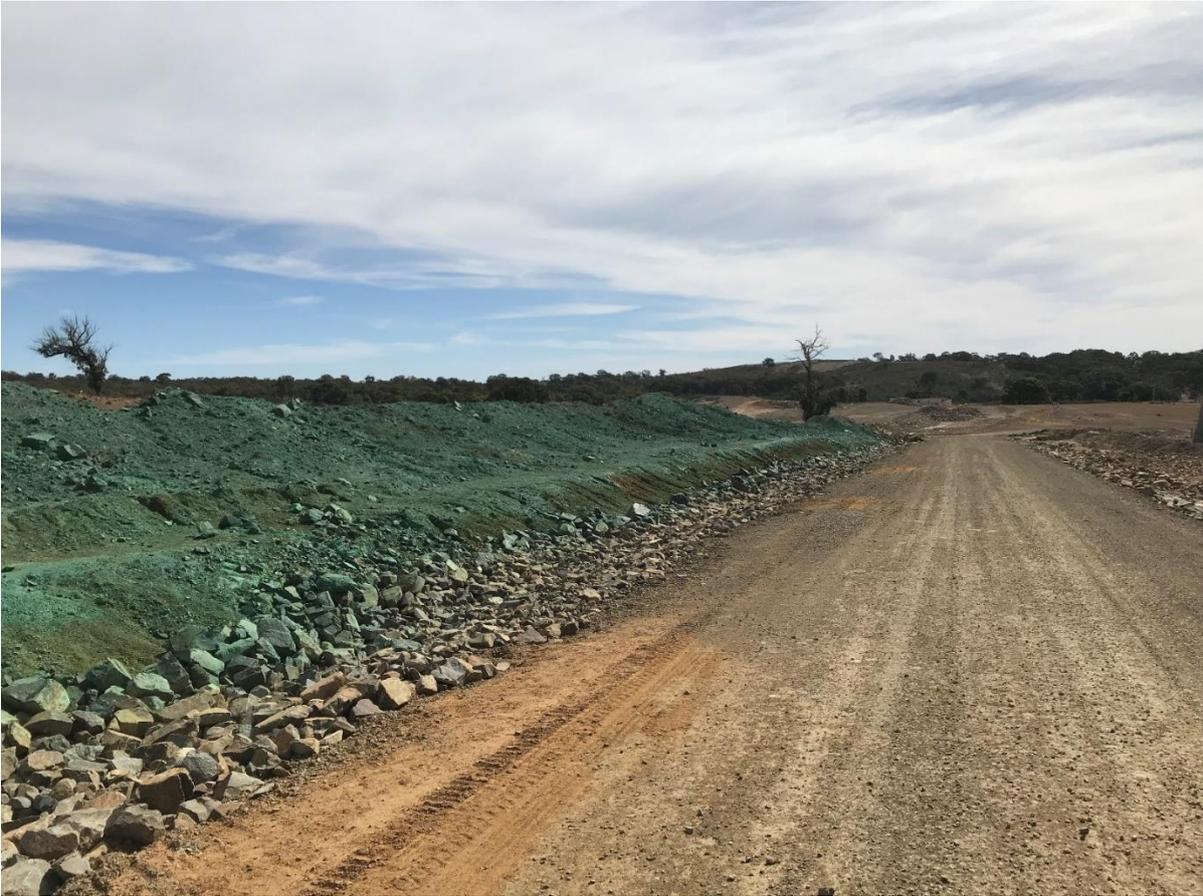
**Figure 7:** Temporary polymer stabilisation (initial coating) applied to Track 5, CG1 higher risk areas where works are currently on hold (March 2019)

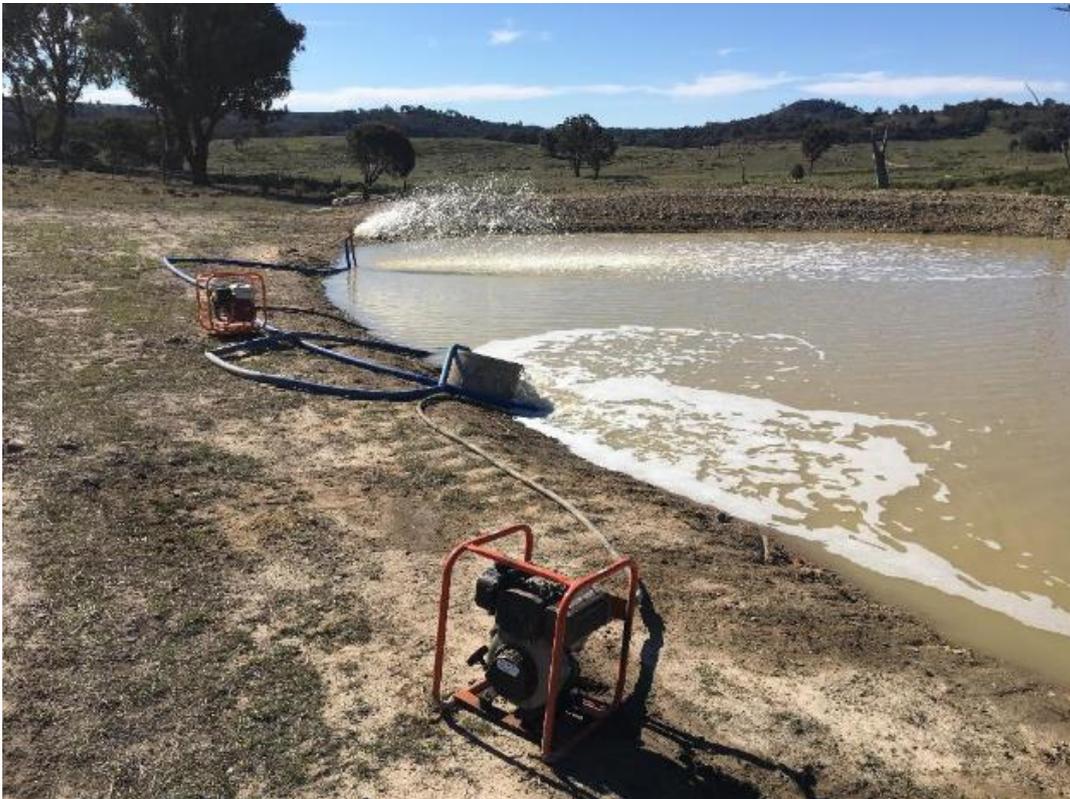
**Figure 8:** Post rain water management (manual flocking in process utilising floc blocks)

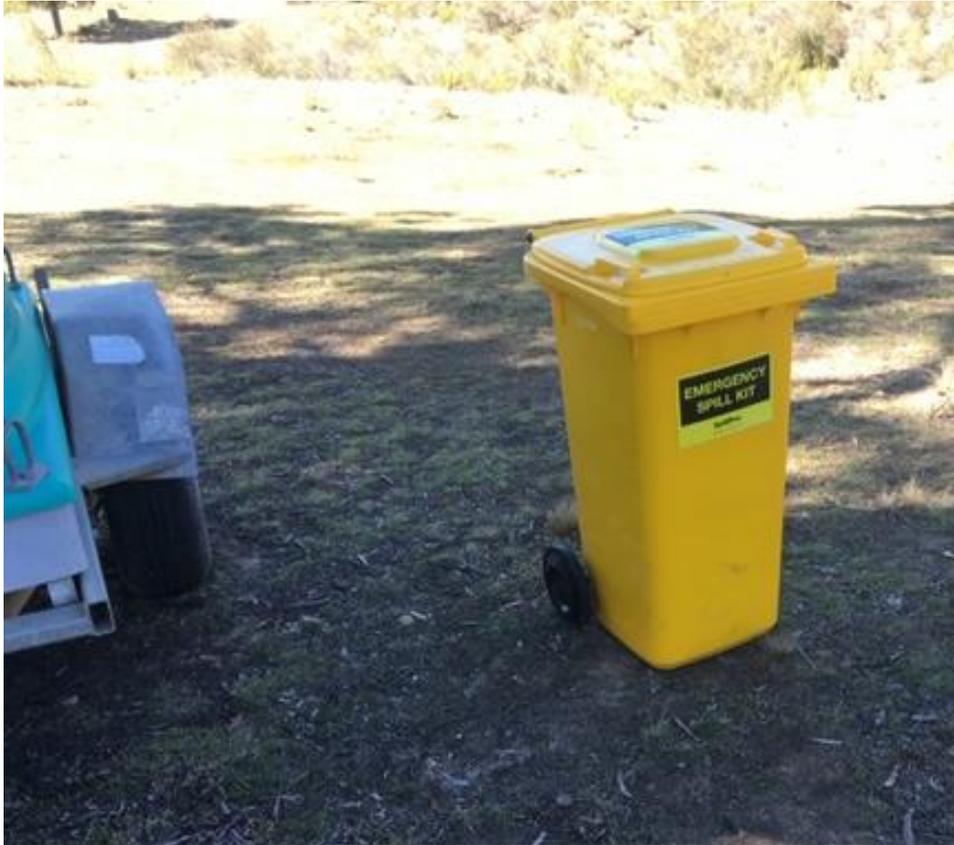
**Figure 9:** 110L Emergency Spill Kit implemented and located at the Vegetation Clearing Crew satellite compound on APR (approx. Ch10,000)

With reference to the Auditor's recommendation to provide additional spill response resources at active refuelling areas, the Contractor clarifies that the referenced fuel cell is located in CG4 on long term stand-down and inactive. However the Contractor has reviewed this recommendation across the broader site and confirms additional Spill Kits and Spill Containment supplies have now been positioned in and around work fronts specifically in the vehicle refuelling areas, as demonstrated in Attachment 2, Figures 9-11.

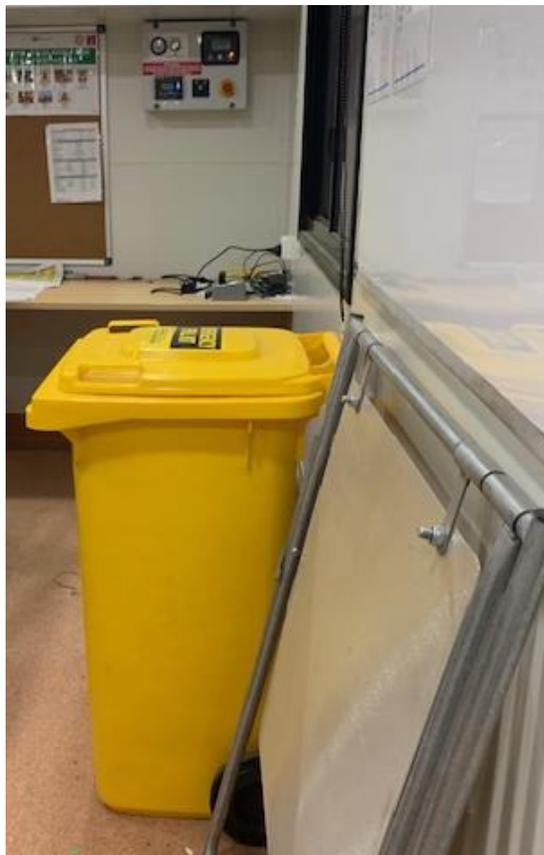
**Figure 10:** 110L Emergency Spill Kit implemented and located at the Civil Crew satellite compound located at the APR / Castlereagh Hwy intersection

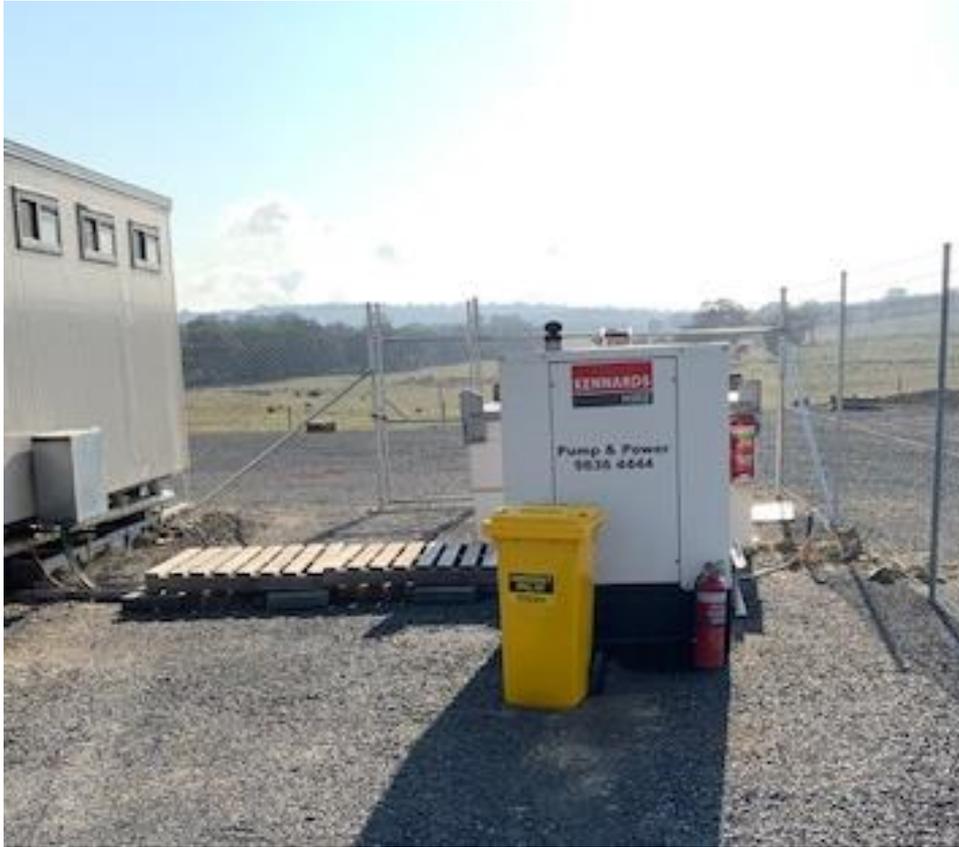
**Figure 11:** 110L Emergency Spill Kit implemented and located at the main compound

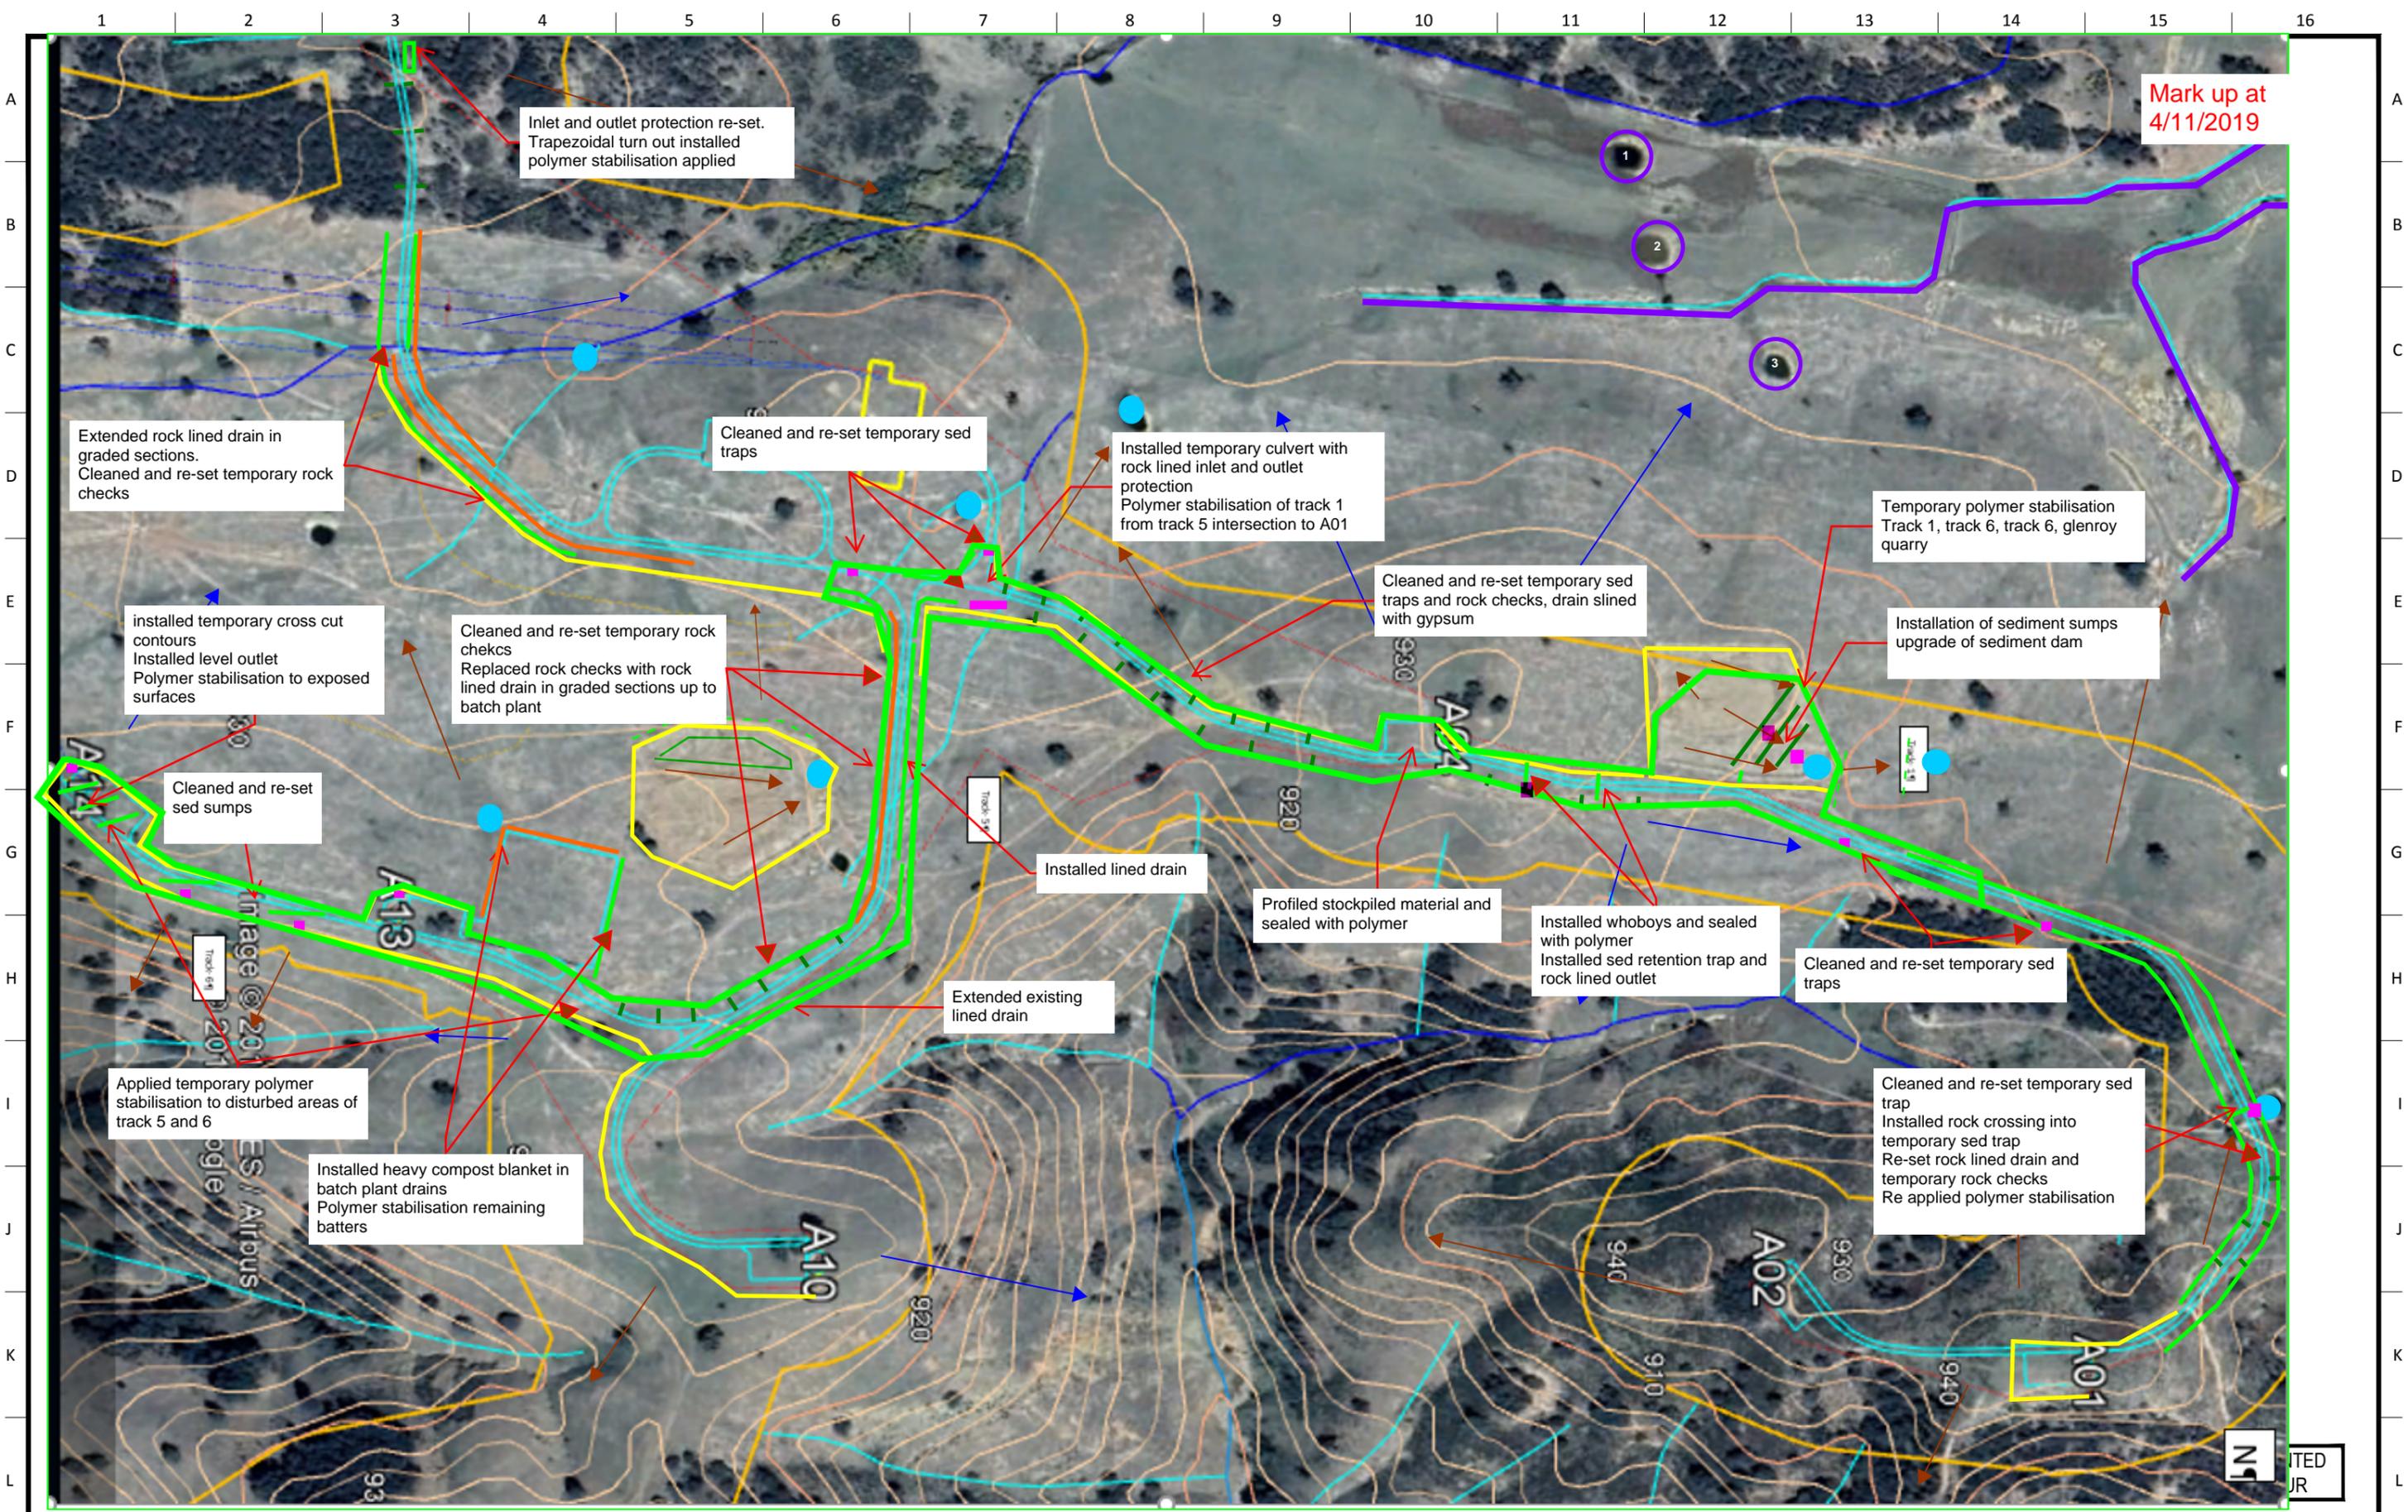
PROJECT CRUDINE RIDGE WIND FARM  
 TITLE Progressive Erosion Sediment Control Plan  
 Wind Farm - Sheet 1  
 DRAWING No. ZX109-DWG-7511-1  
 REV 0

Inlet and outlet protection re-set.  
Trapezoidal turn out installed  
polymer stabilisation applied

Cleaned and re-set temporary rock  
chekcs  
Replaced rock checks with rock  
lined drain in graded sections up to  
batch plant

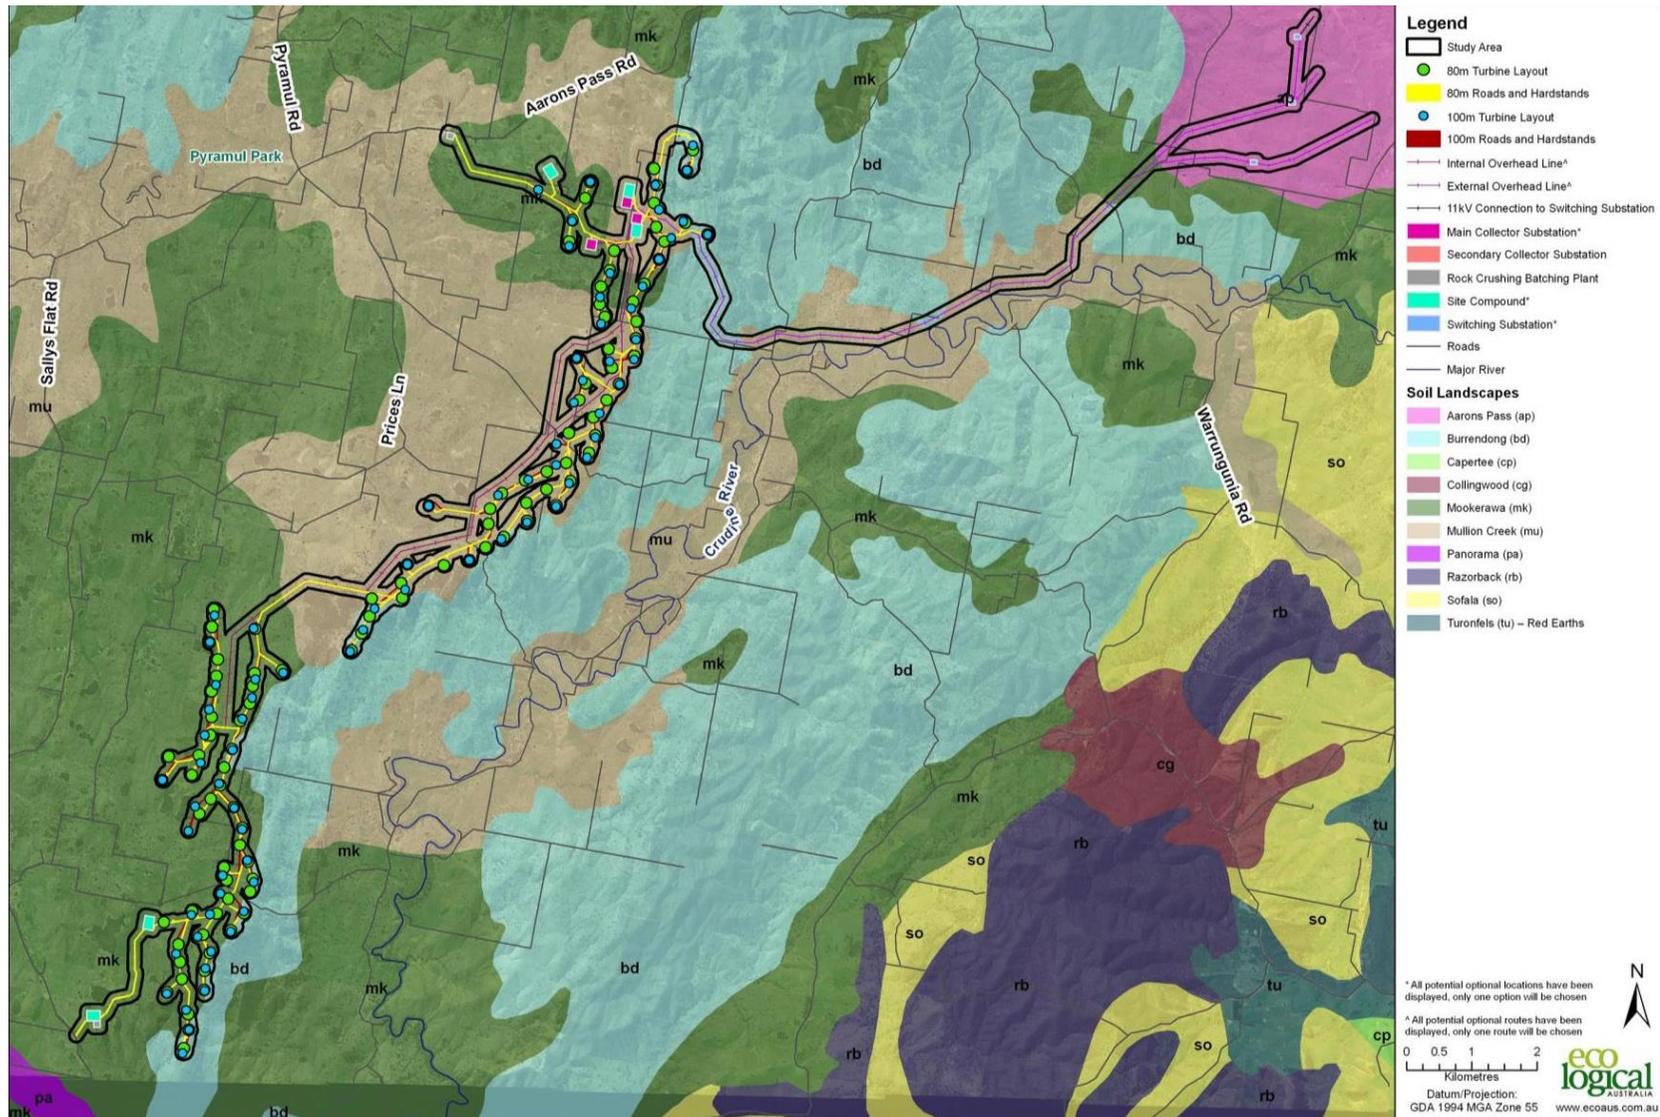
Figure 4.1 – Project soil landscapes (from Figure 6 Eco Logical (2011))

The soils have a high to very high erosion hazard due to the steep slopes and non-cohesive soil properties

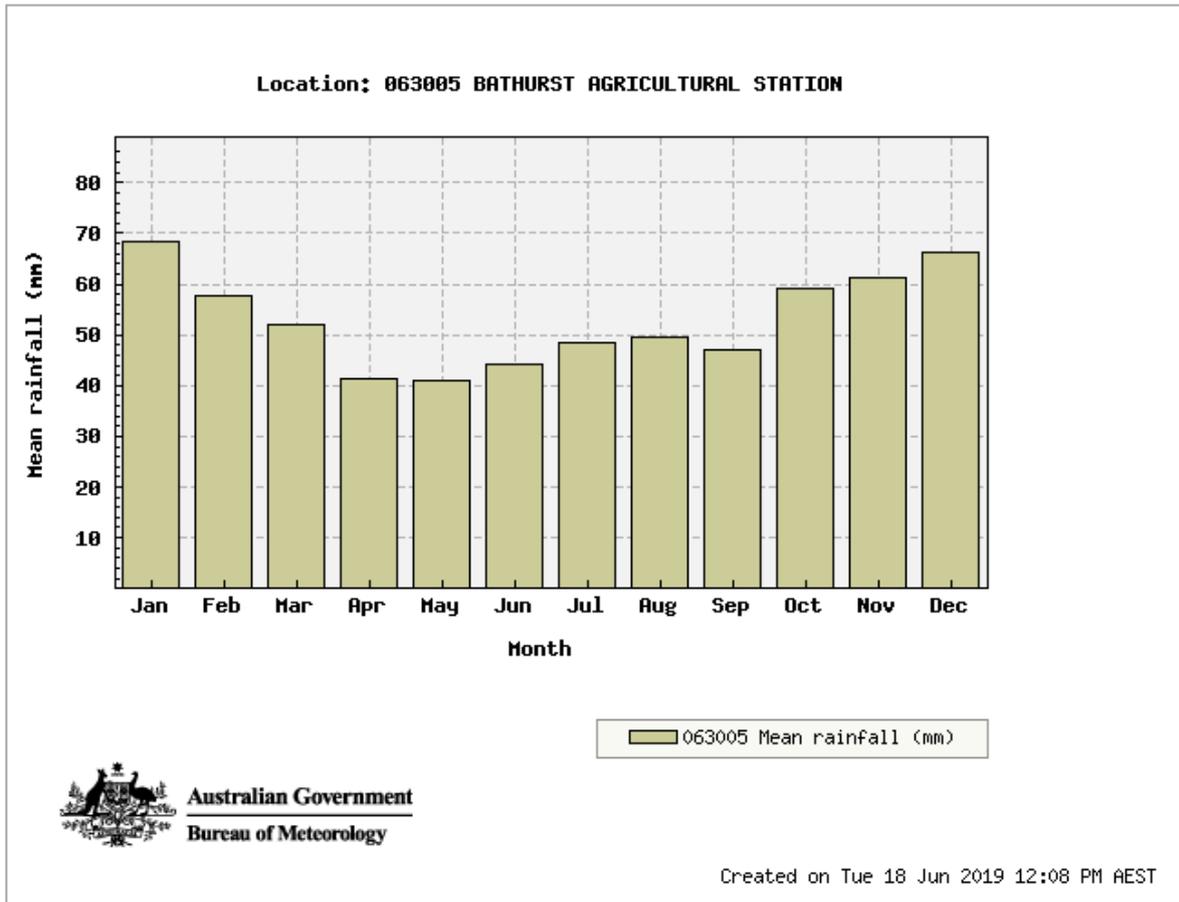
Figure 4.2 – Project area monthly mean rainfall data (BoM 2019)

Monthly rainfall averages are shown in Figure 4.2.
