**Crudine Ridge Wind Farm (SSD-6697) MOD1| Audit Response**

# Crudine Ridge 132/33kV Substation Soil and Water Management - Action Plan

## GEZ Consortium – Crudine Ridge Wind Farm Project

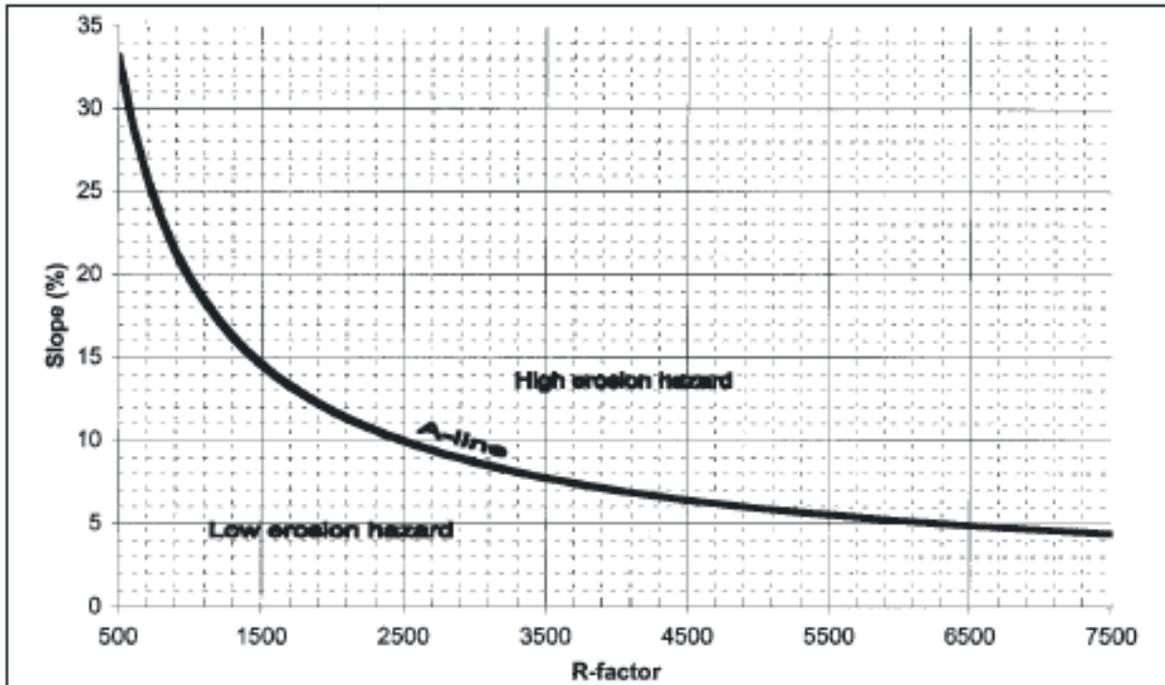
Figure 5.1 Assessment of potential erosion hazard (Figure 4.6 Landcom 2004)

The rainfall erosivity factor (R factor) for the project is 1,336.

Applying the site R factor of 1,336 and upper slope gradients to project soil landscapes and construction areas results in an erosion hazard ranging from low to high. This is presented in Table 5.2.

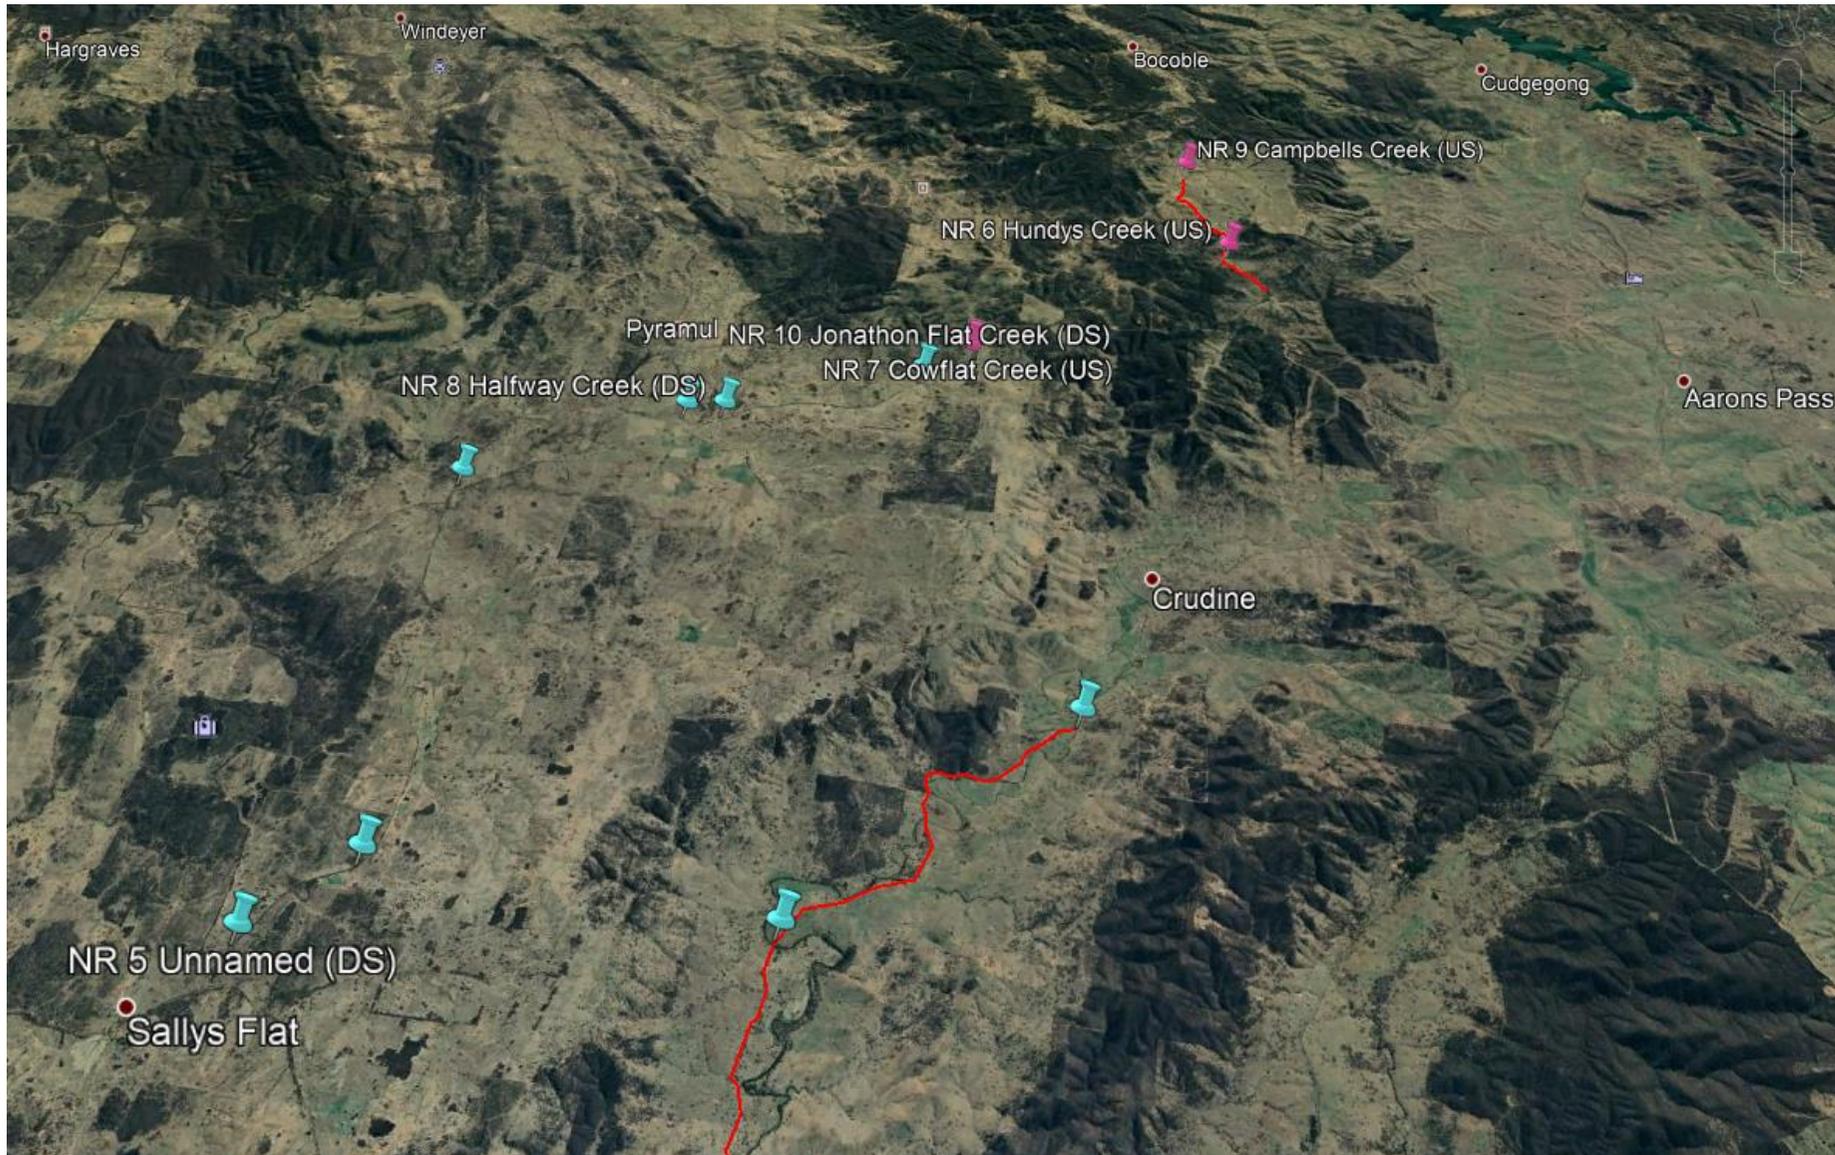
Figure 10.1 – Project water monitoring locations

1. Monthly sampling at all locations
2. Post rainfall sampling at all locations;
  - o July – October 2019 sampling after 10mm> rain events (Within 36hrs of the completion of the rain event)
  - o November 2019 onwards sampling after 20mm> rain events (Within 36hrs of the completion of the rain event)
